Technical report S-17/2012

Investigation of the collision of vessel BESIKTAS PERA against the pier during the docking manoeuvre at the port of Valencia on the 22nd of October 2011.

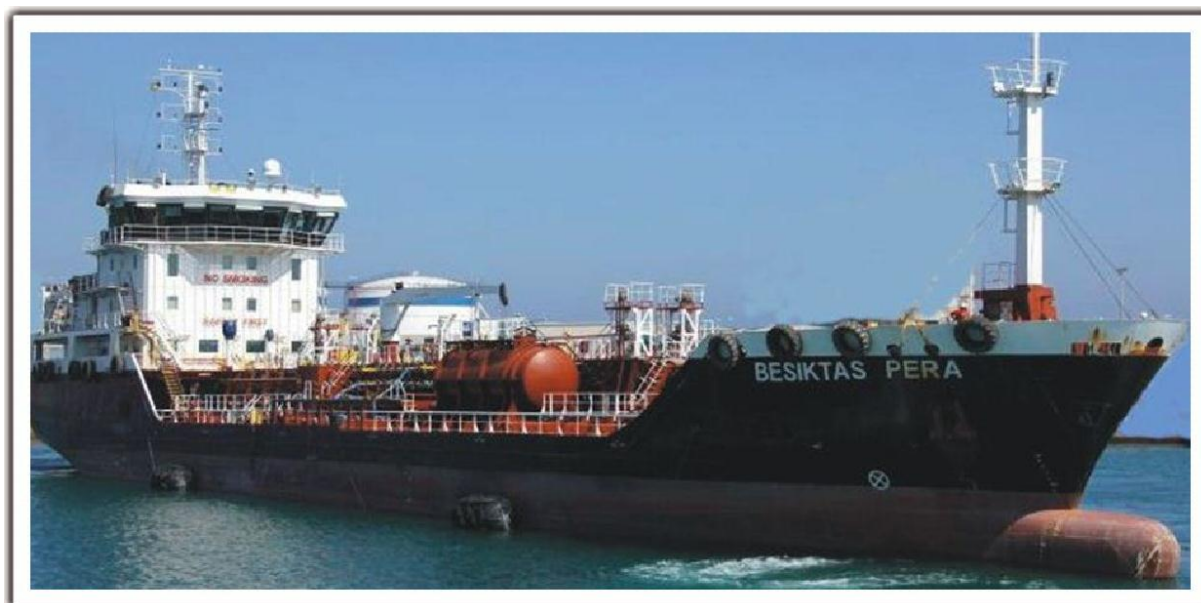
Figure 2. Vessel BESIKTAS PERA

Regarding the main characteristics of the vessel, the following are noted: She has a total length of 98.71 m, a breadth of 14.1 m, a depth of 7.2 m, a maximum draught of 5.8 m, a gross tonnage (GT) of 2,974, a displacement of 5,979 t and deadweight of 4,121 t.
